CHARACTERIZATION OF CERAMIC MATRIX COMPOSITE VANE SUBELEMENTS SUBJECTED TO RIG TESTING IN A GAS TURBINE ENVIRONMENT

Michael Verrilli and Anthony Calomino
NASA Glenn Research Center
21000 Brookpark Road
Cleveland, OH 44135

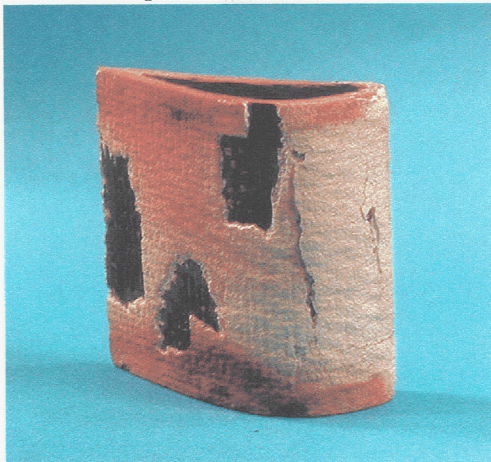
Figure 6 – SiC/SiC vane (number 909) after inadvertent water exposure followed by rig testing for 3.5 hours.

The rig was disassembled to inspect the test section after completion of 50 hours of testing. Water was found in the test section. One of the water-cooled thermocouples was found to have leaked prior to the beginning of the last 3.5 hours of testing. This led to the accumulation of water in the test section between rig runs. During this period of time, the SiC/SiC vane absorbed some of this water. Upon restarting the test, the absorbed water vaporized, producing spallation damage (Figure 6). About 26% of the total coating surface area had spalled.

Because of the damage to the first test vane (number 909), a second EBC-coated vane subelement (number 910) was prepared for continued testing. A 2-minute thermal cycle was employed for this stage of the testing. This cycle consisted of holding the gas temperature at a constant minimum value for 45 seconds, then heating to a maximum over 15 seconds, holding for 45 seconds, and finally cooling back to the minimum temperature in 15 seconds. Initial peak temperatures were based on experience obtained during the steady state testing. However, higher gas temperatures of up to 1420 °C were used for latter cycles. Under the higher gas temperatures, a peak material temperature of 1320 °C was obtained. After 102 cycles were completed, the rig was disassembled.

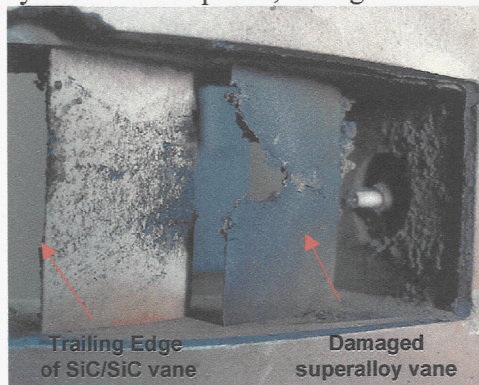
Inspection of the test section after 102 cycles revealed considerable damage of the test section metal hardware. Melting of the superalloy vanes occurred, as well as other test section metal hardware. The SiC/SiC vane subelement was intact but had deposits on the EBC surface (Fig. 7). X-ray diffraction revealed evidence of the Co-based Haynes 188 vane on the suction side of the SiC/SiC vanes, (which can be seen in Fig. 7) and deposits of Ni-based Waspaloy on the pressure side. Note that both these alloys melt above 1400 °C and were used to fabricate test section hardware.

Figure 7 – SiC/SiC (number 910) and superalloy vane subelements after the cyclic testing.

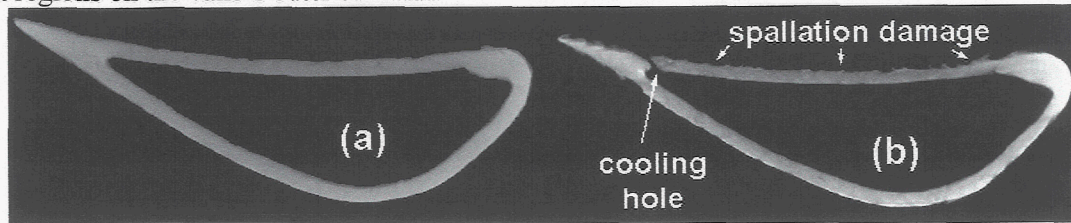
in Figure 8. Spallation damage can be seen in the post-test image, particularly on the pressure (i.e. concave) side of this vane. No composite damage in vane 910 was detected after rig testing using the CT inspection technique (Fig. 9). The superalloy deposits (as can be seen in Fig. 7) appear as the irregular bright regions on the vane's outer surfaces.

Figure 8 – Computed tomography images of vane 909, a) as-fabricated, b) after rig testing for 50 hours under steady state conditions.

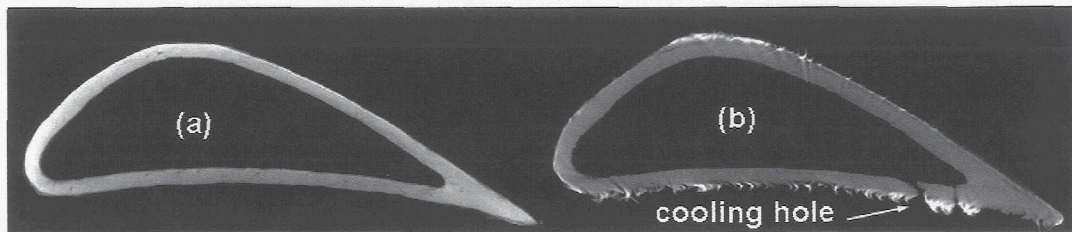
Figure 9 – Computed tomography images of vane 910, a) as-fabricated, b) after rig testing for 102 2-minute cycles.

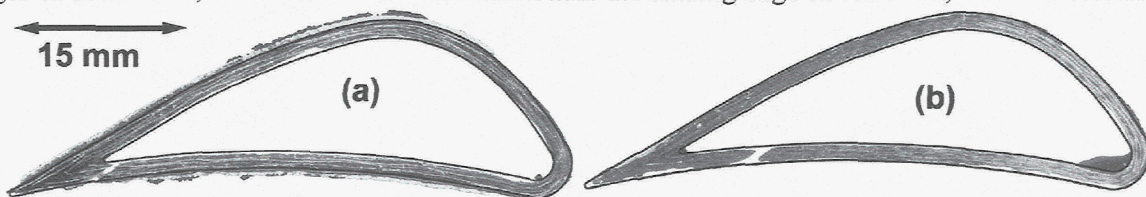
The cross sections of both vanes are shown in Figure 10. Engineering drawings of the inside and outside vane nominal profile are superimposed over the micrographs of the vanes. Both vanes retained their shape even after exposure to severe test conditions. Cooling holes can be seen near the trailing edges of both vanes, and excess matrix is evident near the leading edge of vane 909, on the inside surface.

Figure 10 – Cross sections of SiC/SiC vanes after rig testing, a) vane 910 tested under cyclic conditions, b) vane 909 tested under steady state conditions.

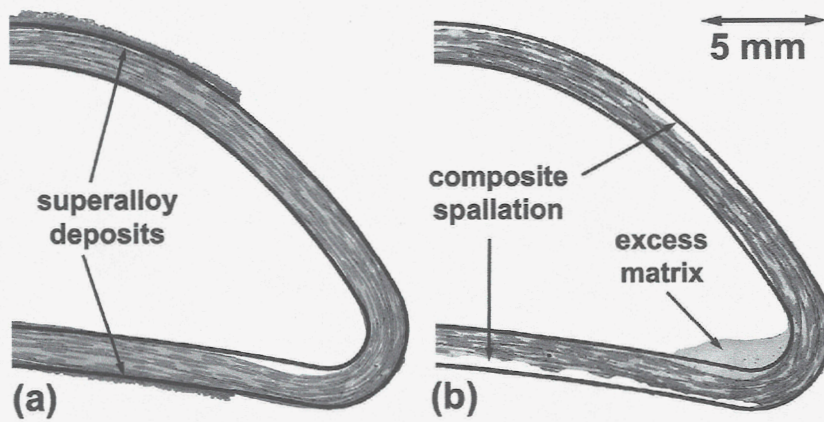
Since the finite element analyses predicted the highest stresses to exist in the leading and trailing edges, it is important to examine the microstructure in these regions. In Figure 11, details of the leading edges are shown. A coating of superalloy can be seen on vane 910 on both the pressure and suction sides, but not at leading edge. Spallation of outer composite plies exists in vane 909 at locations away from the leading edge. However, no cracks exist. In both vanes, the gap on the ID between the actual vane profile and the drawing near the leading edge are the result of the manufacturing process.

Figure 11 – Microstructure of the leading edge of SiC/SiC vane subelements after rig testing, a) vane 910 tested under cyclic conditions, b) vane 909 tested under steady state conditions.

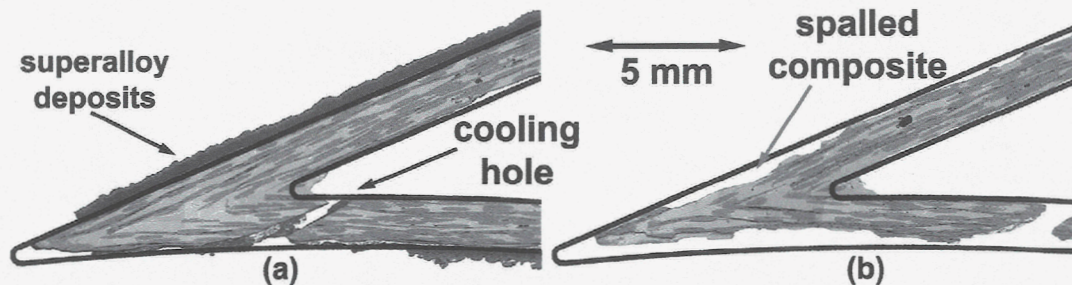
Details of the trailing edge microstructures (Figures 12 and 13) revealed features similar to those seen in the leading edge. Superalloy deposits of about 0.4 mm thickness extend toward the trailing edge radius in vane 910. The deposits cover the EBC but no obvious reaction with the SiC/SiC substrate is evident (Fig. 13a). Composite ply spallation and a crack are visible near the trailing edge of vane 909 (Fig. 12b). The outer ply is missing near the cooling hole while three outer plies

spalled off in the most damaged regions. Figure 13(b) shows a region with one missing ply. The EBC exists in a region with the original six plies. It is likely that this spallation, which occurred during rig start up, resulted in higher stresses in the trailing edge of vane 909 during subsequent rig operation, leading to the cracks as seen in Figs. 12 and 13. In spite of this damage, the trailing edge of vane 909 remained intact.

Figure 12 – Microstructure of the trailing edge of SiC/SiC vane subelements after rig testing, a) vane 910 tested under cyclic conditions, b) vane 909 tested under steady state conditions.

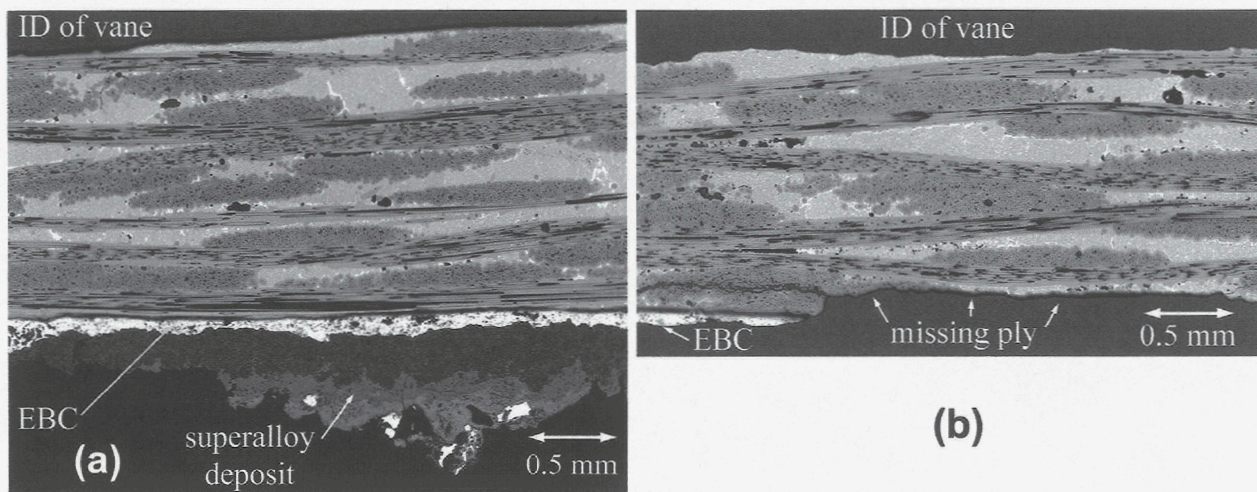
Figure 13- Microstructure of the pressure side of the vanes, 20 mm away from the tip of the trailing edge, a) vane 910 tested under cyclic conditions, b) vane 909 tested under steady state conditions.
